INDIVIDUAL PROPERTY/DISTRICT
MARYLAND HISTORICAL TRUST
INTERNAL NR-ELIGIBILITY REVIEW FORM

Property/District Name: Edward T. Clark Farm Survey Number: HO-647

Survey No. HO-647
Edward Talbott Clark Farm
Buildings Complex
Howard County, MD

Maryland Historical Trust
State Historic Sites Inventory Form

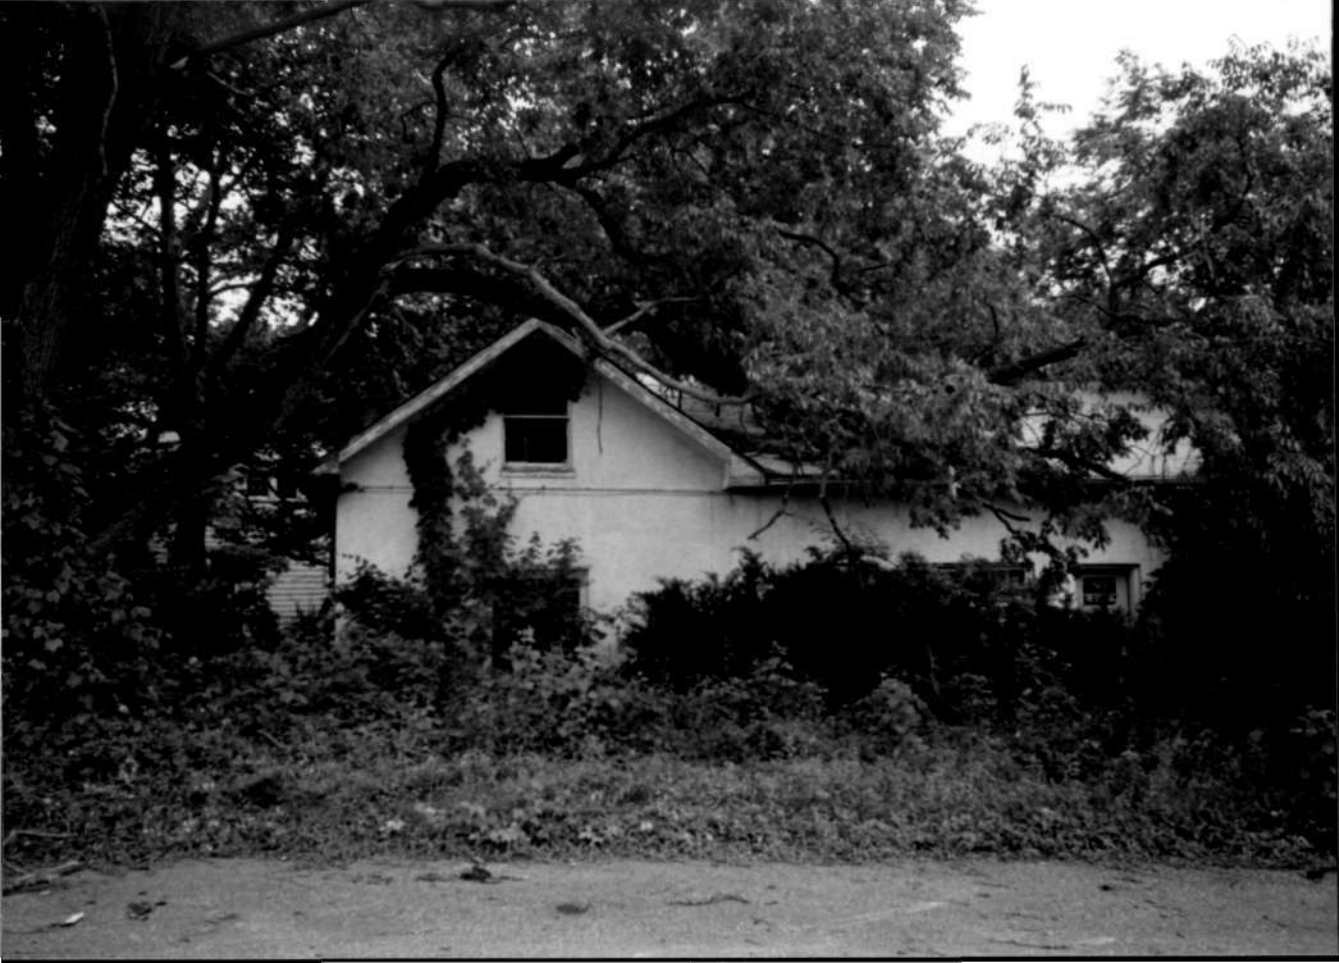
This dwelling is rectangular in shape, 31 feet wide by 43 feet long. The long axis of the building is oriented along a 64 degree magnetic azimuth. This building is constructed of cement block and its exterior finish is stucco. There is a crawl space under the house. The windows are double hung, six over six. The exterior walls of the structure are in good condition. The interior of the building is deteriorated due to lack maintenance. The roof is of the gable type and is "T" shaped. Two brick chimneys extend through the roof, which is covered with asphalt shingles. The roof is severely deteriorated and partially collapsed.

STRUCTURE #1, MINIMAL TRADITIONAL STYLE
DWELLING, FRONT ELEVATION, LOOKING SE.
1 OF 13

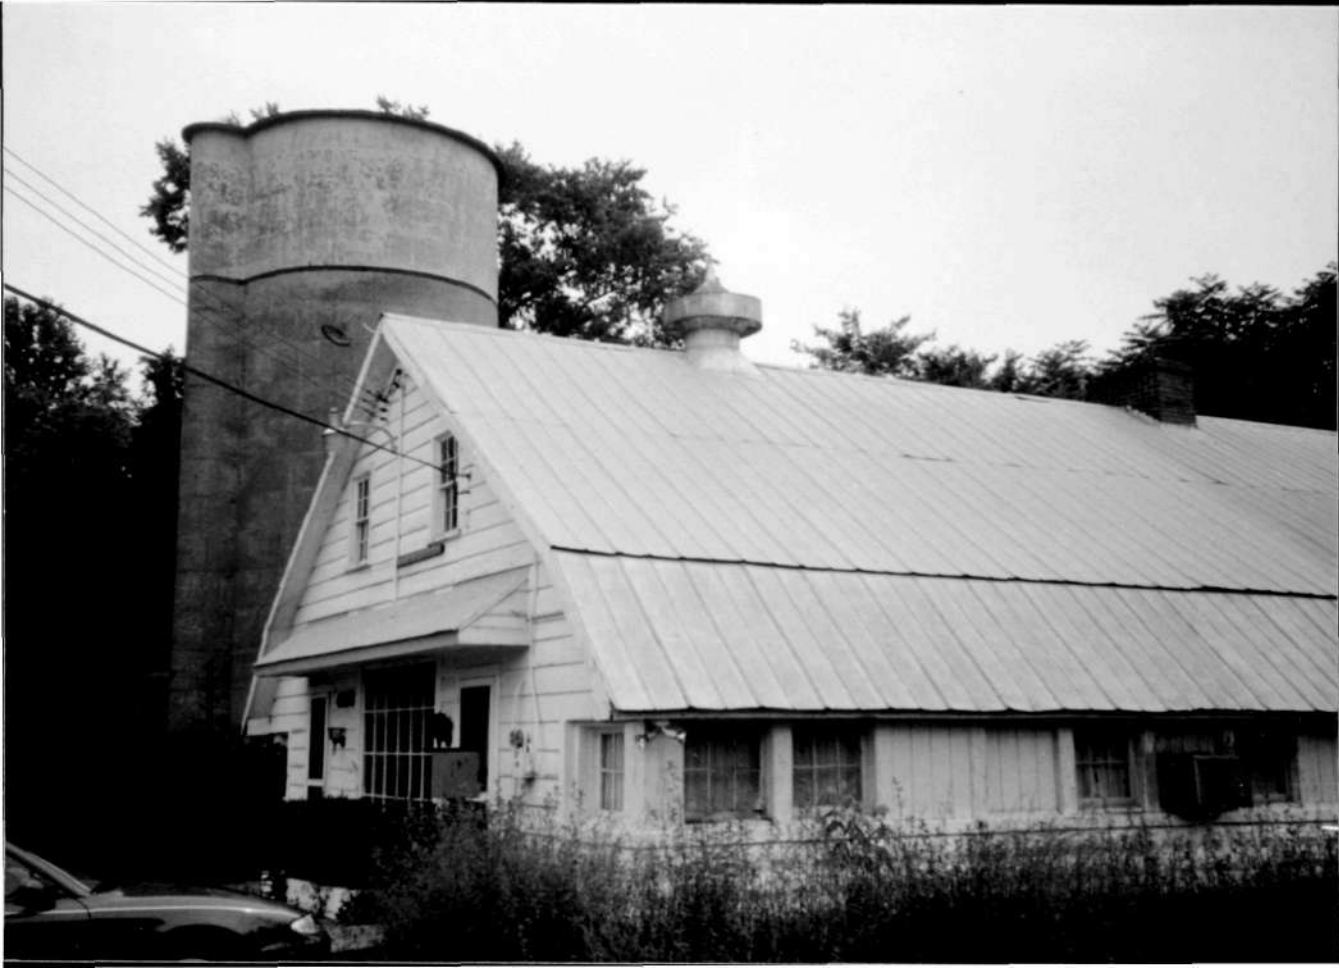
The side walls of Structure # 2 are constructed of concrete masonry units (CMUs) with a 5-inch concrete cap. Above the masonry along both sides of the barn there is a nearly continuous row of six pane sash windows, each 32 inches wide by 30 inches tall. Some of the window openings have been closed off with plywood.

STRUCTURE #2, DAIRY BARN, SIDE ELEVATION,
LOOKING SE.

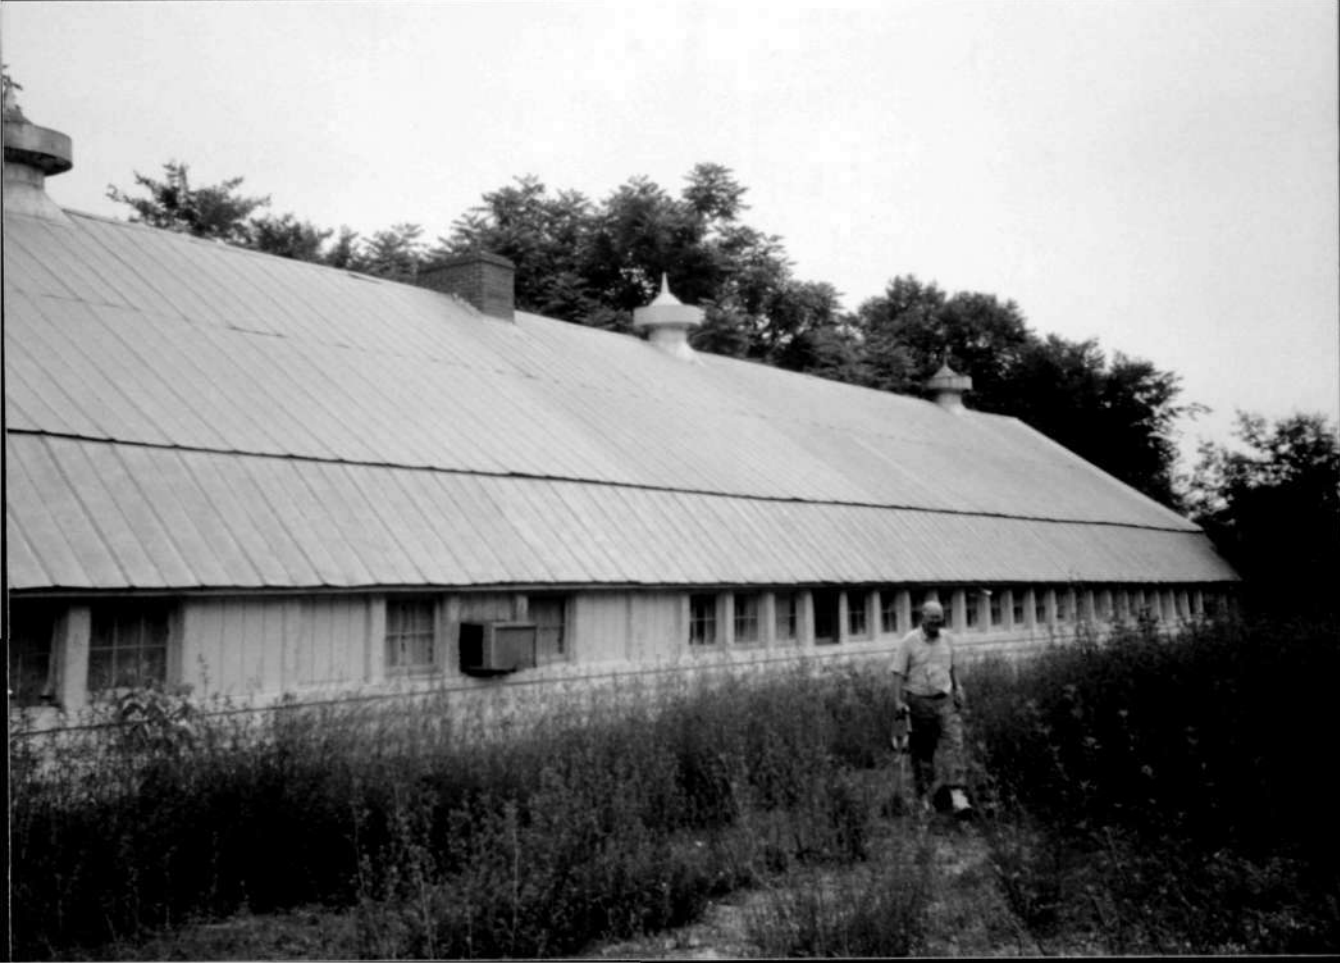
STRUCTURE #2, DAIRY BARN, SIDE ELEVATION,
LOOKING SE.

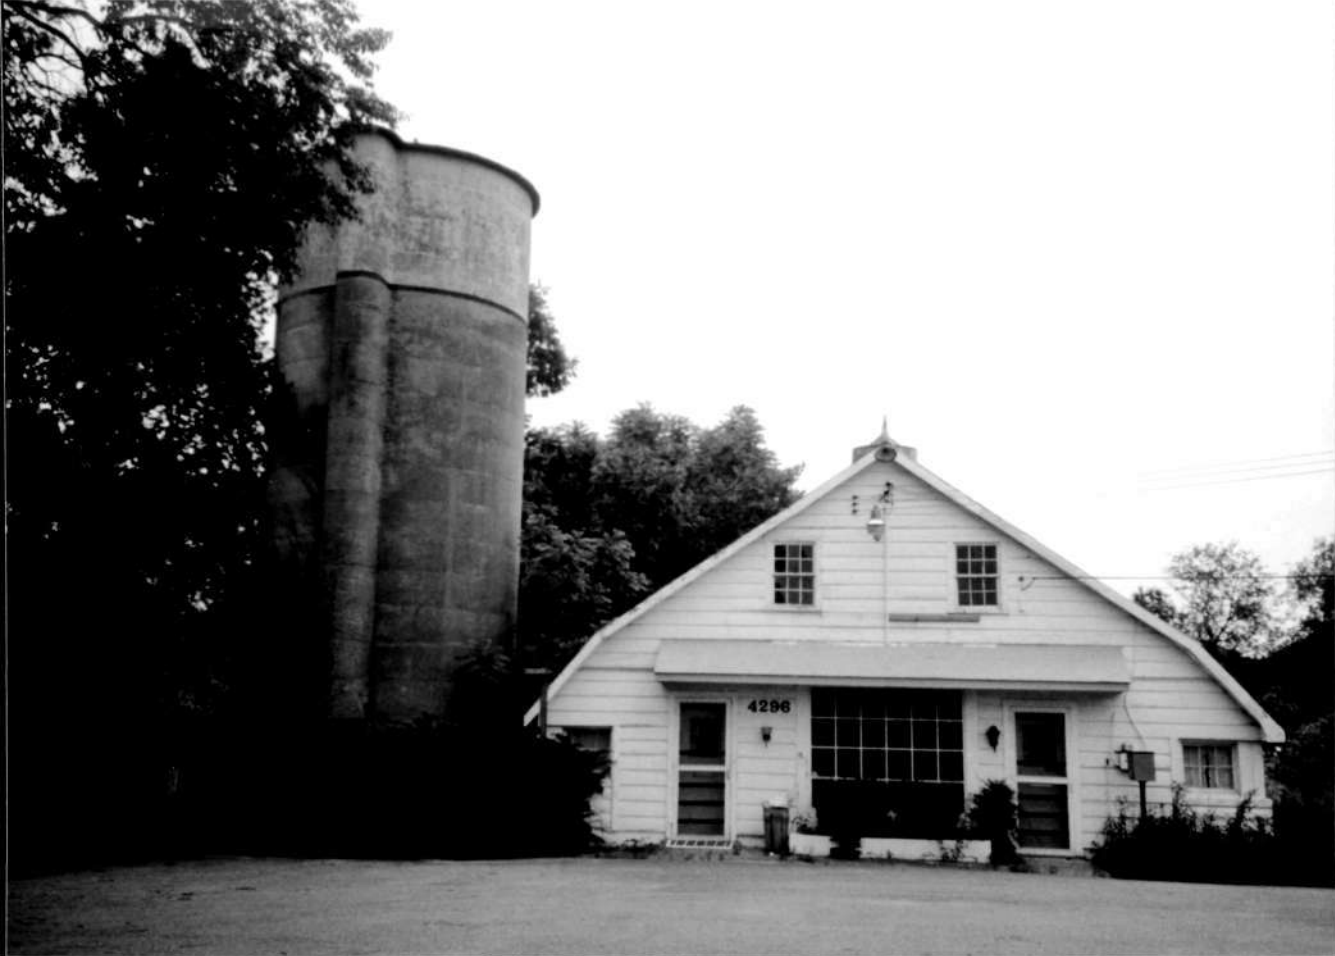
The northern end of the structure faces Montgomery Road and has been remodeled to serve as a real estate office entrance. It is finished with 8-inch beveled wood siding. On the ground floor level at both sides of this end there are single six light sash windows. A large 24 light bay window (8 feet wide by 6 feet 4 inches tall) has been added in the middle of the front end. On either side of the bay window there is a 3-foot by 7-foot door. There are also two loft windows, both six over six, double hung. Above the bay window and adjacent doorways, there is a canopy projecting outward to a distance of 2 feet 3 inches. The canopy is 23 feet 3 inches in length. The opposite (rear) end of the building is built of vertical board and batten siding and has a single large sliding door. There are two loft windows (six over six, double hung), one on either side of a loft door. The roof of the dairy barn is of the gambrel type. It is covered with standing seam metal roofing in good condition. The roof has three steel ventilators and a 28-inch by 48-inch brick chimney.

STRUCTURE #3, SILO, AND STRUCTURE #2, DAIRY BARN
FRONT ELEVATION, LOOKING S.W.

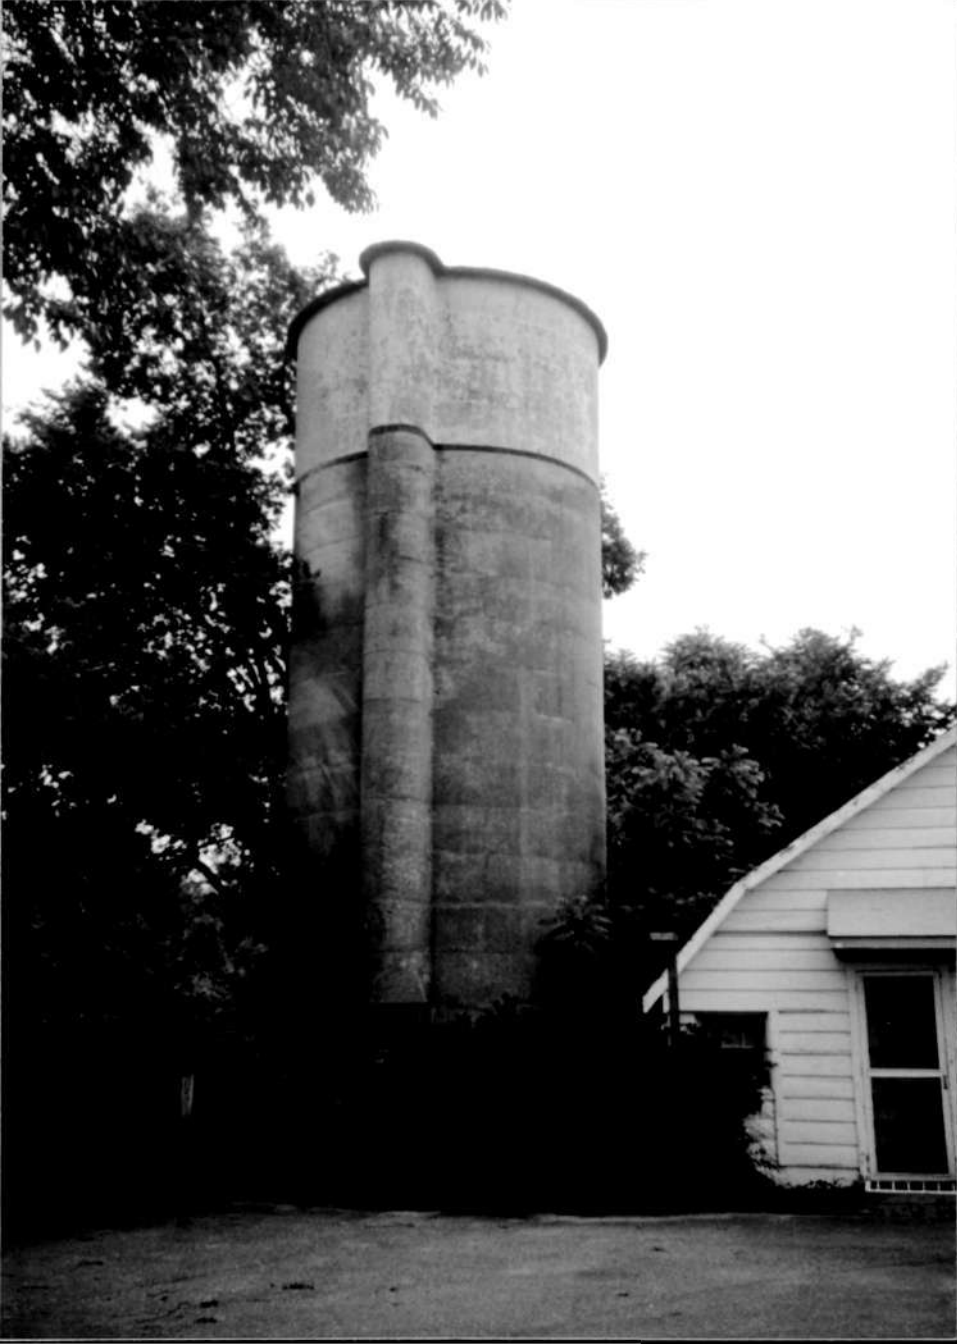
Structure # 3 is located at the northeastern corner of Structure # 2 (dairy barn at 4296 Montgomery Road). It is a silo constructed of steel reinforced concrete with a concrete roof. The silo's diameter is 15 feet and its height is about 35 feet tall.

This structure appears to have been constructed circa 1945, around the same time as the adjoining barn. It is in good condition, though it has not been utilized as a silo at least since the dairy barn was converted for use as a real estate office. Due to the stoutness of its construction, the integrity of this structure is intact.

STRUCTURE #3, SILO, FRONT ELEVATION,
LOOKING SW.

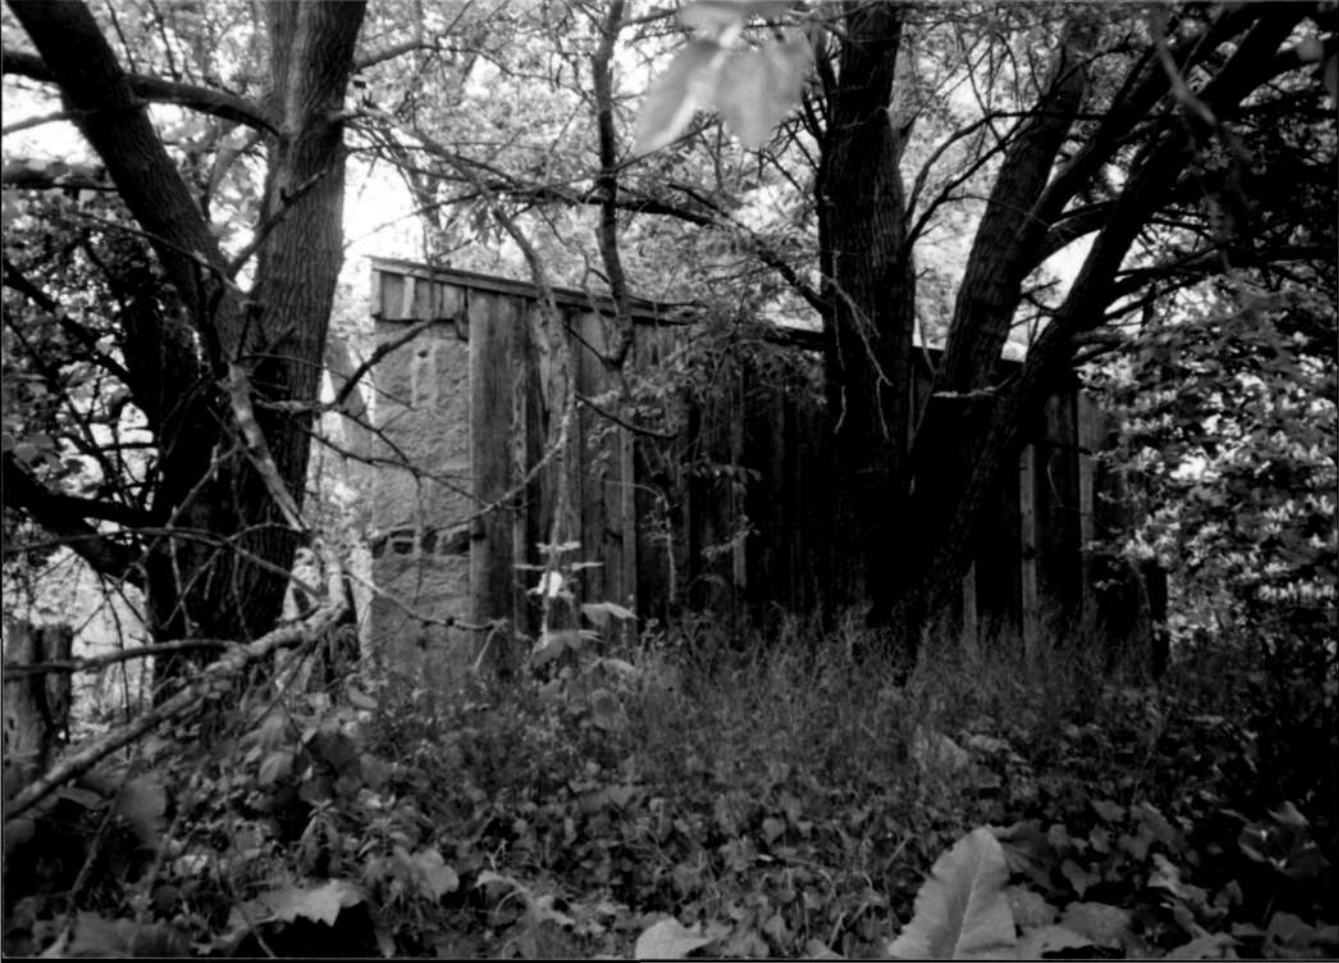
STRUCTURE #5, FRAME SHED WITH STONE WALL,
SOUTHERN END, LOOKING NORTH.

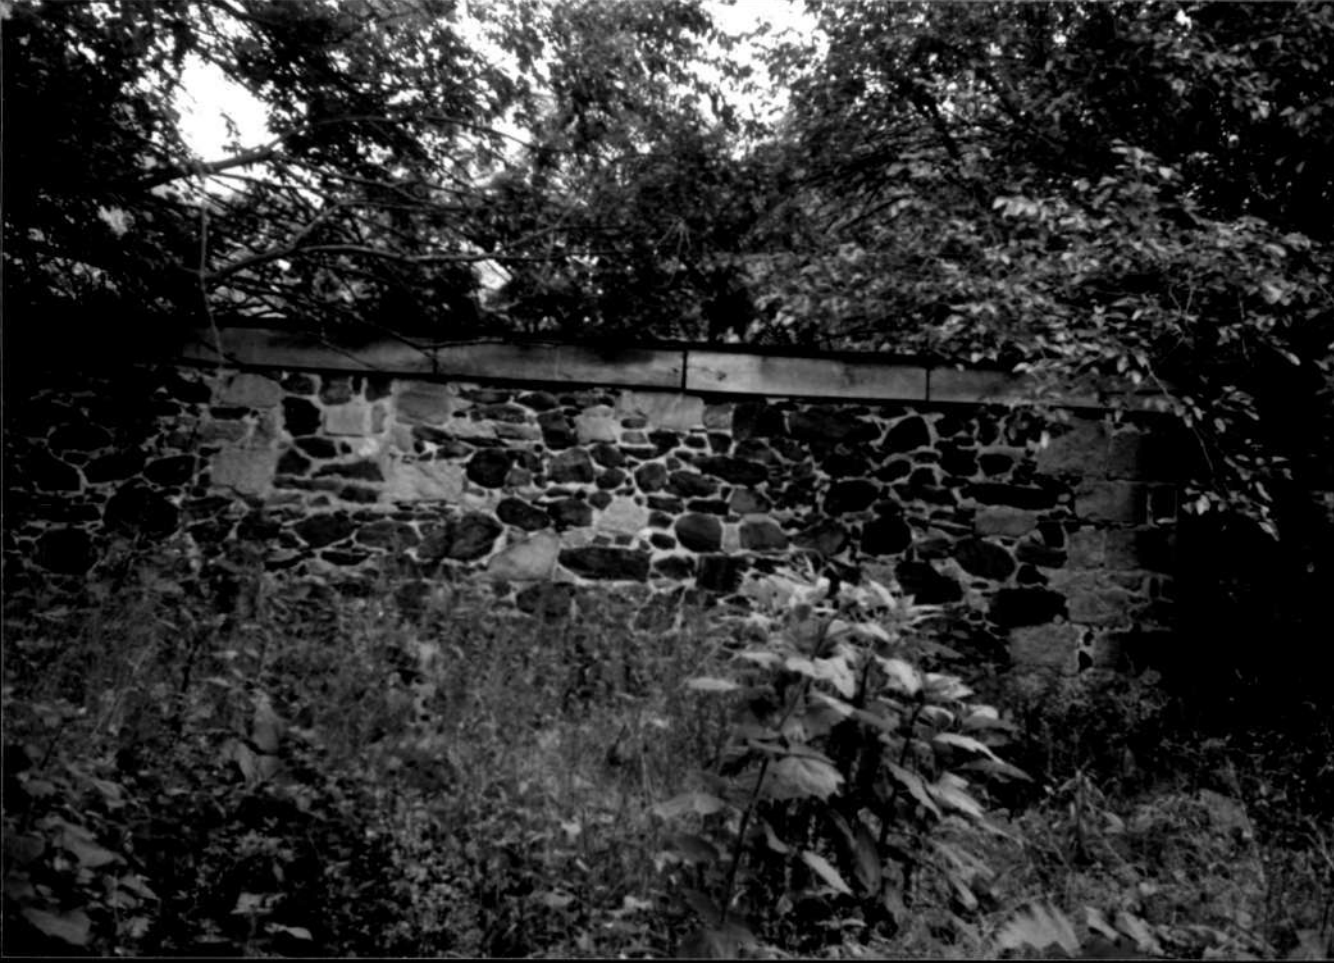
STRUCTURE #5, FRAME SHED WITH STONE WALL
REAR OF WALL LOOKING EAST.

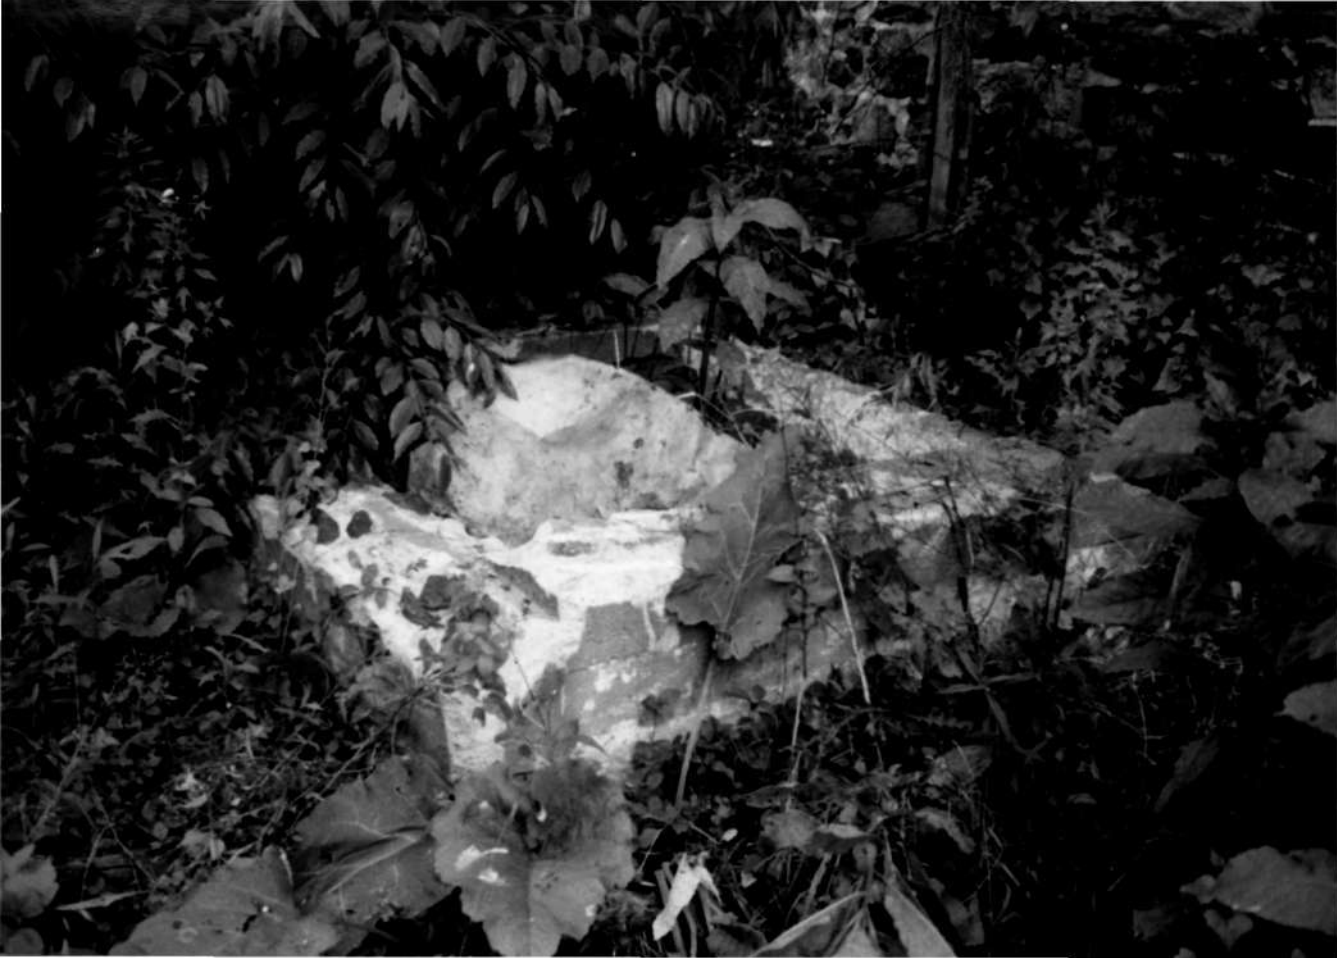
To the rear of Structure # 5 there is a small rectangular concrete outbuilding foundation. It is designated Structure # 6. This feature measures 6 feet by 6 feet square. Its walls are 12 inches thick and rise to 18 inches above ground level. It has one bay.

STRUCTURE #6, OUTBUILDING FOUNDATION,
LOOKING NORTH.

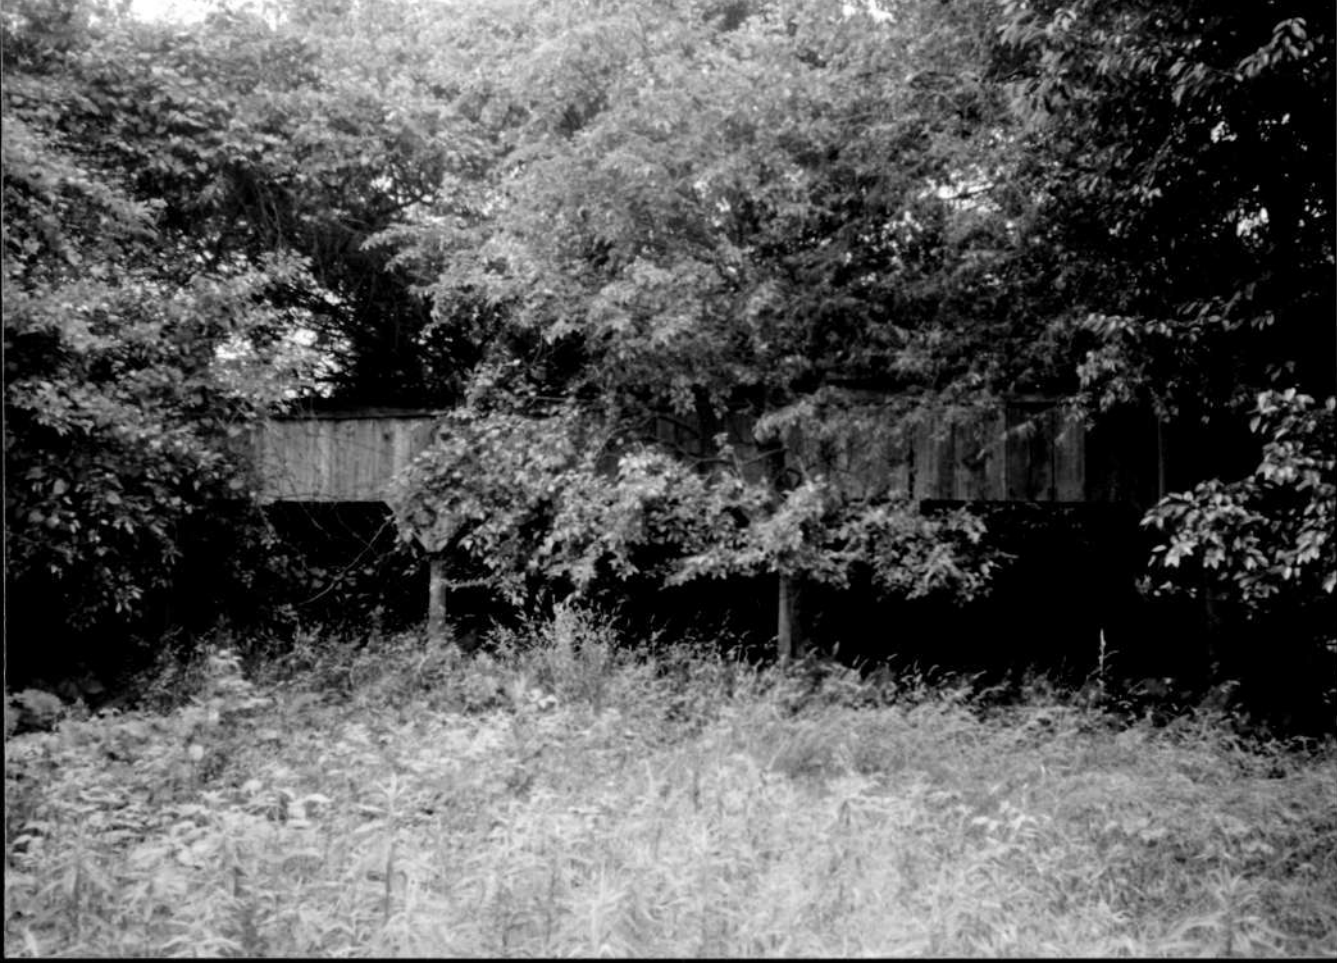
Structure # 7 is a detached shed situated 84 feet south of Structure # 6. It appears to have served as a garage for farm equipment. A piece of abandoned farm machinery was observed adjacent to the structure.

STRUCTURE #7, GARAGE SHED, FRONT
ELEVATION, LOOKING NORTH.
